County Tree Care Ltd

Tree Survey and Arboricultural Assessment at Mallow , Co. Cork

Date : 03/10/24

McCutcheon Halley,
Joyce House,
6 Barrack Square,
Ballincollig,
Co. Cork

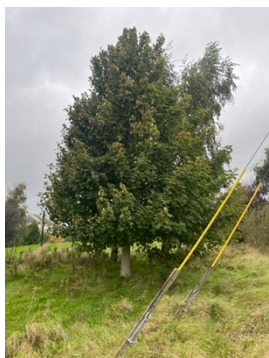
Fig 1: T0131

Tag No.	Species	Coordinates	Age	Height	Diameter	Condition	Crown Spread	RPA (M ²)	Comments	Recommendations	RC	ERC
0131	Sycamore (Acer pseudoplatanus)	52.1381158 ⁰ N 8.6290258 ⁰ W	EM	7 m	290 mm	Fair	N 3 m S 3 m E 1 m W 3 m	38	Straight stem, symmetrical crown structure, small tree that will grow to be very large if not maintained, tar spot (<i>Rhytisma acerinum</i>) on leaf which is commonly seen, healthy tree showing good form	Remove grass from around the base and allow the diffusion of air and water to the root zone	C1	> 20

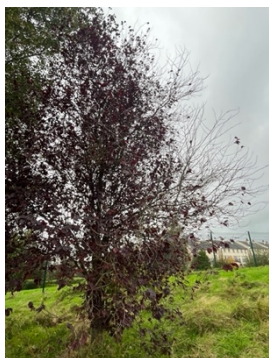
Fig 2: T0132

Tag No.	Species	Coordinates	Age	Height	Diameter	Condition	Crown Spread	RPA (M ²)	Comments	Recommendations	RC	ERC
0132	Ornamental plum (<i>Prunus cerasifera</i>)	52.1381158 ⁰ N 8.6290258 ⁰ W	EM	4 m	150 mm	Fair	N 4 m S 1 m E 2 m W 2m	10	Tree is healthy, restricted branch growth on the East due to the crown of the nearby trees, grows a group that was planted as an amenity and part of a landscape plan, physiological condition good, but a low value tree	Remove grass from around the root zone, thin out the crown by removing crossing branches	C2	< 20

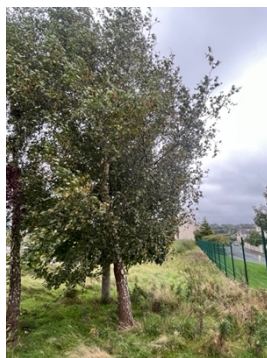
Fig 3: T0133

Tag No.	Species	Coordinates	Age	Height	Diameter	Condition	Crown Spread	RPA (M ²)	Comments	Recommendations	RC	ERC
0133	Silver birch (<i>Betula pendula</i>)	52.1381158 ⁰ N 8.6290258 ⁰ W	M	8 m	220 mm	Good	N 1 m S 2 m E 1 m W 4 m	22	Slight lean North of 10°, stem digresses at 5 m, tree does not have symmetrical form, yet is healthy, grows as part of a small group of 4 no. trees	Remove grass from around the base and allow the diffusion of air and water to the root zone	C2	> 20

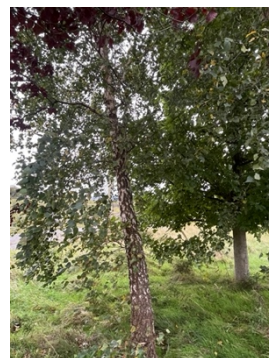
Fig 4: T0134

Tag No.	Species	Coordinates	Age	Height	Diameter	Condition	Crown Spread	RPA (M ²)	Comments	Recommendations	RC	ERC
0134	Silver birch (<i>Betula pendula</i>)	52.1381158 ⁰ N 8.6290258 ⁰ W	M	8 m	20 cm	Fair	N 2 m S 1 m E 1 m W 1 m	18	Lean of 20° heavily North, poor crown formation due to competition from adjacent trees, heavy grass growth at the base, the lean of the tree is a concern but presently there are no targets	Remove grass at the rootzone and allow air and water to circulate to the roots	C2	< 10

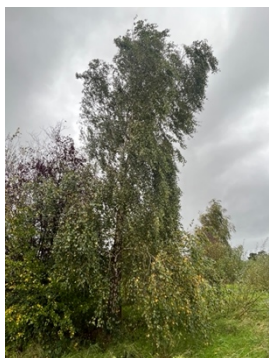
Fig 5: T0135

Tag No.	Species	Coordinates	Age	Height	Diameter	Condition	Crown Spread	RPA (M ²)	Comments	Recommendations	RC	ERC
0135	Silver birch (<i>Betula pendula</i>)	52.1382770°N 8.6291556°W	EM	11 m	28 cm	Fair	N 3 m S 2 m E 3 m W 4 m	34	Tree leans 10° North, bifurcation of the stem at 5 m, poor union at 5 m, good branch development, heavy grass grows around the base, healthy tree	Remove grass at the rootzone and allow air and water to circulate to the roots	C2	< 20

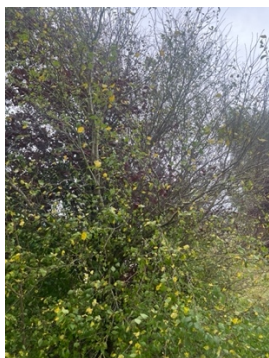
Fig 6: T0136

Tag No.	Species	Coordinates	Age	Height	Diameter	Condition	Crown Spread	RPA (M ²)	Comments	Recommendations	RC	ERC
0136	Ornamental plum (<i>Prunus cerasifera</i>)	52.1382770°N 8.6291556°W	EM	8 m	28 cm (x 2)	Fair	N 1 m S 2 m E 2 m W 1 m	17	Small ornamental tree that was planted as part of a landscape plan, an amenity tree that is overgrown with pioneering grey willow, thick grass grows at the base	Remove willow tree that intertwines the crown, remove grass from around the base	C2	< 20

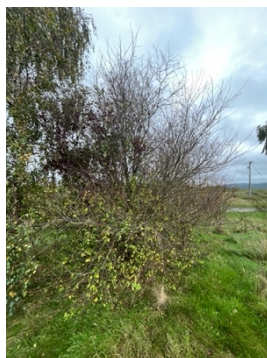
Fig 7: T0137

Tag No.	Species	Coordinates	Age	Height	Diameter	Condition	Crown Spread	RPA (M ²)	Comments	Recommendations	RC	ERC
0137	Ornamental plum (<i>Prunus cerasifera</i>)	52.1383500°N 8.6294798°W	EM	4 m	27 cm (x 2)	Fair	N 1 m S 2 m E 2 m W 2 m	16	Twin stem from the base, overgrown by a self-seeded grey willow tree, crown has many tangled and crossing branches, dense grass grows at the base	Remove willow tree, remove grass from the base, prune to reshape and to remove any crossing branches	C2	< 20

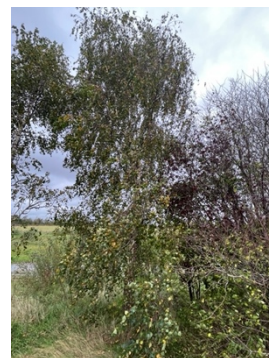
Fig 8: T0138

Tag No.	Species	Coordinates	Age	Height	Diameter	Condition	Crown Spread	RPA (M ²)	Comments	Recommendations	RC	ERC
0138	Silver birch (<i>Betula pendula</i>)	52.1383500°N 8.6294798°W	EM	8 m	20 cm	Fair	N 2 m S 2 m E 1 m W 2 m	18	Tree leans slightly North 10°, stem digresses at 4 m, poorly shaped crown with restricted branch growth on the West	Crown raise to 3 m, remove grass from around the base	C2	< 20

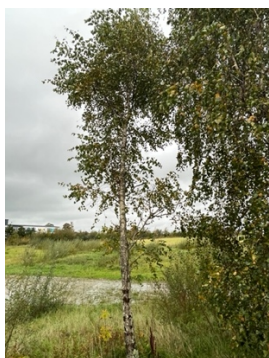
Fig 9: T0139

Tag No.	Species	Coordinates	Age	Height	Diameter	Condition	Crown Spread	RPA (M ²)	Comments	Recommendations	RC	ERC
0139	Silver birch (<i>Betula pendula</i>)	52.1383500 ⁰ N 8.6294798 ⁰ W	EM	7 m	15 cm	Fair	N 1 m S 1 m E 1 m W 1 m	10	Tree leans North 20°, poorly developed branch structure, a weak tree	Remove grass from around the base, retain for the short term, no work required presently	C2	< 10

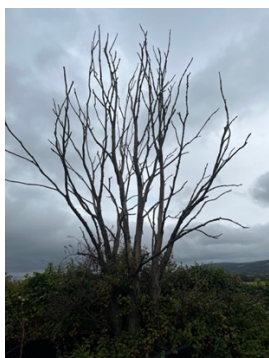
Fig 10: T0140

Tag No.	Species	Coordinates	Age	Height	Diameter	Condition	Crown Spread	RPA (M ²)	Comments	Recommendations	RC	ERC
0140	Wych elm (<i>Ulmus glabra</i>)	52.1380224 ⁰ N 8.6243675 ⁰ W	EM	6 m	35 cm	Dead	N 2 m S 2 m E 2 m W 2 m	NA	Dead tree that leans against an old stone wall	Fell and remove	U	< 1

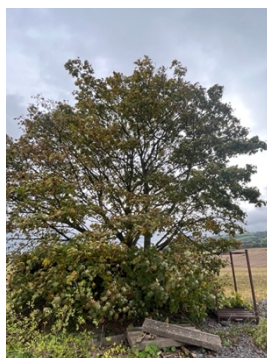
Fig 11: T0141

Tag No.	Species	Coordinates	Age	Height	Diameter	Condition	Crown Spread	RPA (M ²)	Comments	Recommendations	RC	ERC
0141	Sycamore (<i>Acer pseudoplatanus</i>)	52.1378891 ⁰ N 8.6242857 ⁰ W	M	7 m	54 cm (x 2)	Fair	N 4 m S 3 m E 3 m W 4 m	38	Grows against an old stone wall, ground level has been changed, the soil has been pushed up around the base, the roots covered on the South side, squat shape, a low quality tree and will never be a tree of any merit	Remove to facilitate the development	C3	< 1

On the East side there are 9 no. trees that are recommended to be felled. Two of these, no's T141, T145 are in the grey category but are low quality trees and are to be felled for reasons connected to the development.

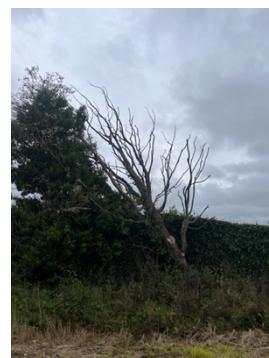
Fig 12: T0142

Tag No.	Species	Coordinates	Age	Height	Diameter	Condition	Crown Spread	RPA (M ²)	Comments	Recommendations	RC	ERC
0142	Wych elm (<i>Ulmus glabra</i>)	52.1374471 ⁰ N 8.6240289 ⁰ W	M	6 m	35 cm	Dead	N 2 m S 2 m E 2 m W 2 m	NA	Dead tree that leans against an old stone wall	Fell and remove	U	< 1

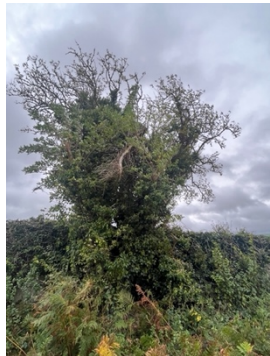
Fig 13: T0143

Tag No.	Species	Coordinates	Age	Height	Diameter	Condition	Crown Spread	RPA (M ²)	Comments	Recommendations	RC	ERC
0143	Elder (<i>Sambucus nigra</i>)	52.1372291 ⁰ N 8.6239182 ⁰ W	M	7 m	40 cm (x 2)	Poor	N 3 m S 3 m E 2 m W 2 m	72	Grows against a stone wall, very heavily engulfed with ivy, twin stem, broken branches throughout the crown, unhealthy tree and low quality specimen	Fell and remove	U	< 1

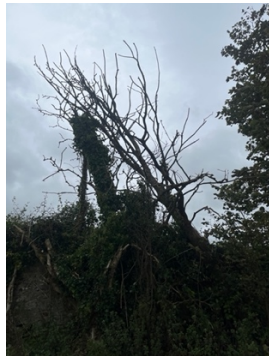
Fig 14: T0144

Tag No.	Species	Coordinates	Age	Height	Diameter	Condition	Crown Spread	RPA (M ²)	Comments	Recommendations	RC	ERC
0144	Wych elm (<i>Ulmus glabra</i>)	52.1371378 ⁰ N 8.6238860 ⁰ W	M	6 m	26 cm	Dead	N 2 m S 2 m E 2 m W 2 m	NA	Dead tree that leans against an old stone wall	Fell and remove	U	< 1

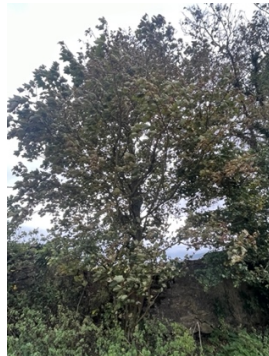
Fig 15: T0145

Tag No.	Species	Coordinates	Age	Height	Diameter	Condition	Crown Spread	RPA (M ²)	Comments	Recommendations	RC	ERC
0145	Sycamore (<i>Acer pseudoplatanus</i>)	52.1371553 ⁰ N 8.6238706 ⁰ W	M	9 m	30 cm	Fair	N 3 m S 3 m E 1 m W 2 m	41	Grows against a stone wall, large branch twists and grows against the stem, cambium damage at 1 m, poorly shaped tree, basal sweep North from 1 m, low quality specimen	Remove to facilitate the development	C3	< 1

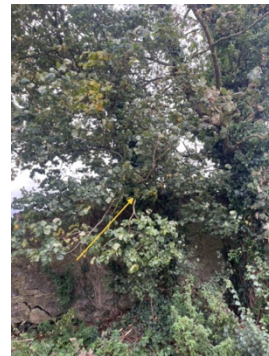
Fig 16: T0146

Tag No.	Species	Coordinates	Age	Height	Diameter	Condition	Crown Spread	RPA (M ²)	Comments	Recommendations	RC	ERC
0146	Wych elm (<i>Ulmus glabra</i>)	52.1371001 ⁰ N 8.6238481 ⁰ W	Y	4 m	15 cm	Fair	N 1 m S 3 m E 1 m W 1 m	10	Small tree that grows as an understorey to the sycamore, a low quality specimen that will eventually succumb to elm disease	Fell and remove	U	< 1

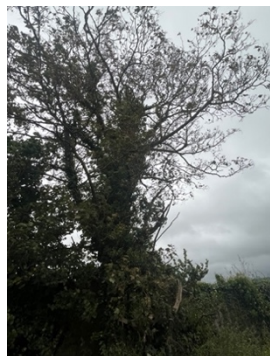
Fig 17: T0147

Tag No.	Species	Coordinates	Age	Height	Diameter	Condition	Crown Spread	RPA (M ²)	Comments	Recommendations	RC	ERC
0147	Sycamore (<i>Acer pseudoplatanus</i>)	52.1370431 ⁰ N 8.6238139 ⁰ W	M	9 m	50 cm	Poor	N 4 m S 4 m E 4 m W 4 m	113	Grows against a stone wall, very heavily engulfed with ivy, stem digresses East, dieback seen throughout the crown, multiple broken branches throughout the crown, low quality specimen	Fell and remove	U	< 1

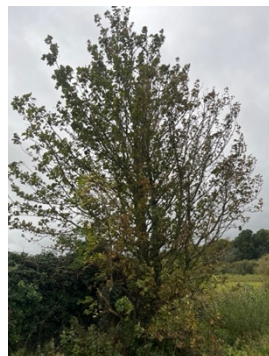
Fig 18: T0148

Tag No.	Species	Coordinates	Age	Height	Diameter	Condition	Crown Spread	RPA (M ²)	Comments	Recommendations	RC	ERC
0148	Sycamore (<i>Acer pseudoplatanus</i>)	52.1368455 ⁰ N 8.6237020 ⁰ W	EM	6 m	58 cm (x 3)	Fair	N 2 m S 3 m E 3 m W 3 m	150	Multiple stems (3) from the base, compressed union at the base, soil has been pushed up around the base by machinery, poorly shaped tree and low quality	Fell and remove	U	< 1

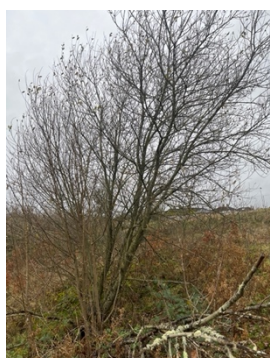
Fig 21: T0149

Tag No.	Species	Coordinates	Age	Height	Diameter	Condition	Crown Spread	RPA (M ²)	Comments	Recommendations	RC	ERC
0149	Grey willow (<i>Salix cinerea</i>)	52.1348049 ⁰ N 8.6275952 ⁰ W	EM	5 m	72cm (x 6)	Fair	N 2 m S 2 m E 2 m W 2 m	41	Multiple stems (6) from the base, compressed union at the base, self-seeded tree, low value pioneering specimen	Retain for the short to medium term	C2	< 10

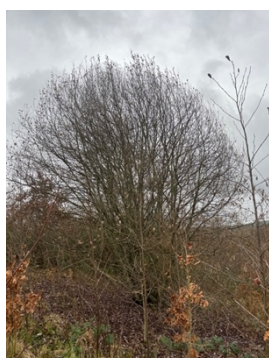
Fig 22: T0150

Tag No.	Species	Coordinates	Age	Height	Diameter	Condition	Crown Spread	RPA (M ²)	Comments	Recommendations	RC	ERC
0150	Grey willow (<i>Salix cinerea</i>)	52.1348317 ⁰ N 8.6273568 ⁰ W	M	5 m	30 cm	Fair	N 2 m S 2 m E 2 m W 2 m	41	One main stem with multiple branches growing from .5m, self-seeded tree and a low value specimen	Retain for the short to medium term	C2	< 10

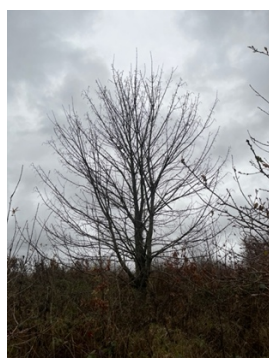
Fig 23: T0151

Tag No.	Species	Coordinates	Age	Height	Diameter	Condition	Crown Spread	RPA (M ²)	Comments	Recommendations	RC	ERC
0151	Sycamore (<i>Acer pseudoplatanus</i>)	52.1349624 ⁰ N 8.6273300 ⁰ W	EM	8 m	28 cm	Fair	N 4 m S 4 m E 4 m W 4 m	35	Stem divides into multiple branches at .5 m, straight main stem, symmetrical crown, an evenly balanced branch structure	Retain for the short to medium term	C1	> 20

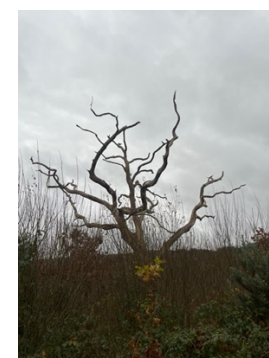
Fig 24: T0152

Tag No.	Species	Coordinates	Age	Height	Diameter	Condition	Crown Spread	RPA (M ²)	Comments	Recommendations	RC	ERC
0152	Oak (<i>Quercus Ssp</i>)	52.1350465 ⁰ N 8.6267241 ⁰ W	M	15 m	85 cm	Dead	NA	NA	Dead Tree	Fell and remove	U	< 1

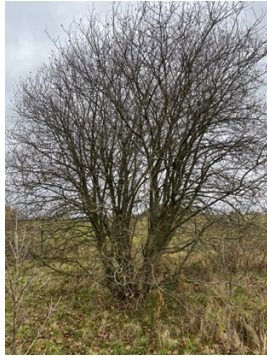
Fig 25: T0153

Tag No.	Species	Coordinates	Age	Height	Diameter	Condition	Crown Spread	RPA (M ²)	Comments	Recommendations	RC	ERC
0153	Grey willow (<i>Salix cinerea</i>)	52.1352318°N 8.6265548°W	M	4 m	150 cm (x 10)	Fair	N 1 m S 1 m E 1 m W 1 m	65	Multiple stems (10) from the base, compressed union at the base, poorly shaped tree and low quality	Retain for the short to medium term	C2	< 10

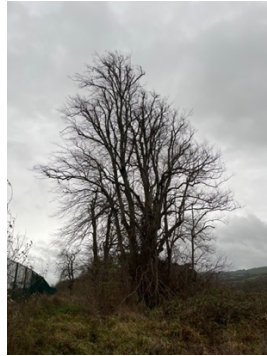
Fig 26: T0154

Tag No.	Species	Coordinates	Age	Height	Diameter	Condition	Crown Spread	RPA (M ²)	Comments	Recommendations	RC	ERC
0154	Common lime (<i>Tilia x europea</i>)	52.1353128°N 8.6258846°W	M	21 m	137 cm (x 4)	Poor	N 4 m S 4 m E 3 m W 3 m	222	Multi-stemmed tree (4), dieback seen throughout the crown and upper tips, major cavity on West stem @ 1.5 m, major cambium damage at 2 m East stem, cavity at 2 m on North stem, multiple pocket cavities on all stems throughout the crown, tree is lacking in vigour and is a potential future hazard	Fell and remove	U	< 1

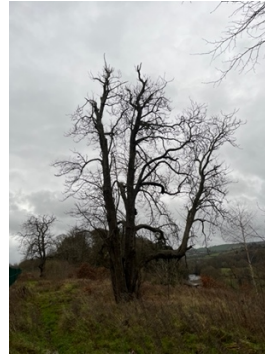
Fig 27: T0155

Tag No.	Species	Coordinates	Age	Height	Diameter	Condition	Crown Spread	RPA (M ²)	Comments	Recommendations	RC	ERC
0155	Horse chestnut (<i>Aesculus hippocastanum</i>)	52.1353470°N 8.6255902°W	M	19 m	180 cm (x 2)	Poor	N 5 m S 7 m E 5 m W 3 m	707	Twin stem from the base, two very large stems, major cambium damage on main stem West side @ .5 m, large cavity on Southerly stem @ 1.5 m, large cavity on Northerly stem @ 2 m, cavity@ 3 m Northerly stem, cavity @ 5 m Northerly stem, major dieback in the crown, tree is in poor health and will be a potential hazard	Fell and remove	U	< 1

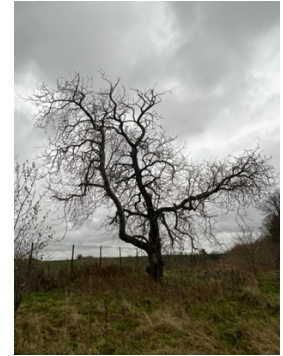
Fig 28: T0156

Tag No.	Species	Coordinates	Age	Height	Diameter	Condition	Crown Spread	RPA (M ²)	Comments	Recommendations	RC	ERC
0156	Horse chestnut (<i>Aesculus hippocastanum</i>)	52.1354452°N 8.6249787°W	M	17 m	114 cm (x 2)	Poor	N 5 m S 7 m E 3 m W 6 m	290	Large tree in poor health, large branch rip out and cavity on main stem @ 1 m West side, tree is infected with honey fungus (<i>Armillaria</i> Ssp), major dieback in the crown, large rip out and cavity on main stem on East side @ 3 m, large rip out @ 15 m North side on main stem, tree will be a future hazard	Fell and remove	U	< 1

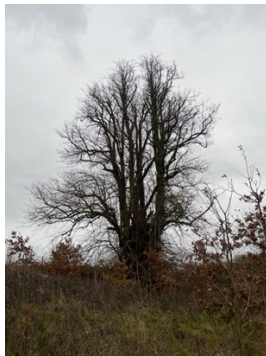
Fig 29: T0157

Tag No.	Species	Coordinates	Age	Height	Diameter	Condition	Crown Spread	RPA (M ²)	Comments	Recommendations	RC	ERC
0157	Common lime (<i>Tilia x europea</i>)	52.1354024°N 8.6240678°W	M	24 m	220 cm (x 2)	Poor	N 4 m S 6 m E 4 m W 7 m	707	Large tree, enormous bole to 2 m, multiple stems from 3 m, two main stems @ 2 m, multiple branch failure throughout the crown, major dieback in upper crown	Fell and remove	U	< 1

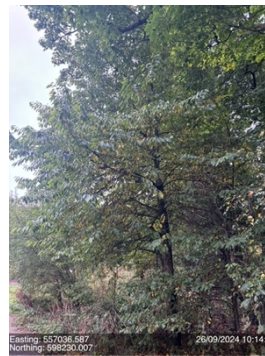
Fig 31: T0182

Tag No.	Species	Coordinates	Age	Height	Diameter	Condition	Crown Spread	RPA (M ²)	Comments	Recommendations	RC	ERC
0182	Bird cherry (<i>Prunus padus</i>)	⁰ N 8.373936 ⁰ W	M	12 m	280 mm	Fair	N 3 m S 3 m E 3 m W 3 m	35.4	Tree grows 2 m South of the pathway, lower branches have been cut, minor deadwood throughout the crown, healthy tree	Deadwood - remove major deadwood	B2	>25

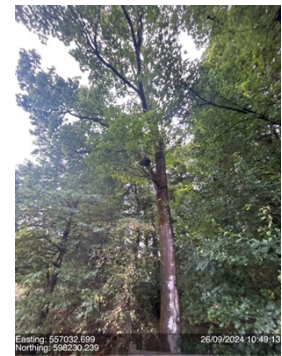
Fig 32: T0183

Tag No.	Species	Coordinates	Age	Height	Diameter	Condition	Crown Spread	RPA (M ²)	Comments	Recommendations	RC	ERC
0183	Norway maple (<i>Acer platanoides</i>)	52.833514 ⁰ N 8.373946 ⁰ W	M	16 m	800 mm	Poor	N 10 m S 3 m E 8 m W 3 m	289.3	Large Norway maple, extensive basal decay on main stem, infected also with Hypoxylon canker, major dieback in upper crown, large branches and weight extending North over pathway, tree is a hazard, fell ASAP	Tree is an immediate hazard, Fell and remove ASAP	U	< 1

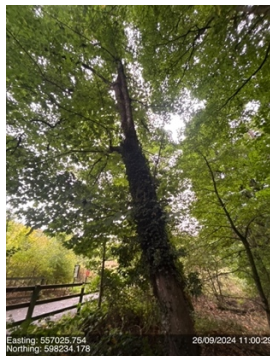
Fig 33: T0184

Tag No.	Species	Coordinates	Age	Height	Diameter	Condition	Crown Spread	RPA (M ²)	Comments	Recommendations	RC	ERC
0184	Sycamore (<i>Acer pseudoplatanus</i>)	52.834769°N 8.373983°W	M	12 m	280 mm	Fair	N 3 m S 3 m E 3 m W 3 m	35.4	Tree grows 2 m South of the pathway, lower branches have been cut, minor deadwood throughout the crown, healthy tree	Deadwood - remove major deadwood	B2	>25

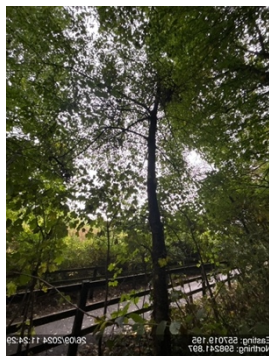
Fig 34: T0185

Tag No.	Species	Coordinates	Age	Height	Diameter	Condition	Crown Spread	RPA (M ²)	Comments	Recommendations	RC	ERC
0185	Bird cherry (<i>Prunus padus</i>)	52.134368°N -8.627827°W	M	9 m	220 mm	Fair	N 4 m S 1 m E 3 m W 2 m	22	Leaning tree over the pathway, of fair health	Reduce height by 2 m to reduce lever arm at the base	C2	< 25

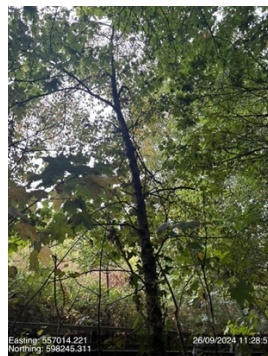
Fig 35: T0186

Tag No.	Species	Coordinates	Age	Height	Diameter	Condition	Crown Spread	RPA (M ²)	Comments	Recommendations	RC	ERC
0186	Silver birch (<i>Betula pendula</i>)	52.13439 °N -8.6279 °W	M	6 m	120 mm	Fair	N 5 m S 1 m E 2 m W 2 m	7	Small diameter tree, leans 80 degrees North over pathway, typical woodland specimen	No work required	C2	>25

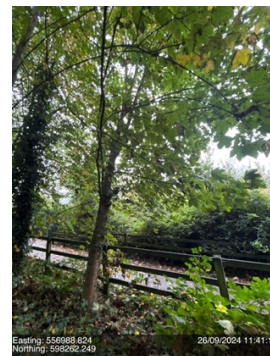
Fig 36: T0187

Tag No.	Species	Coordinates	Age	Height	Diameter	Condition	Crown Spread	RPA (M ²)	Comments	Recommendations	RC	ERC
0187	Sycamore (<i>Acer pseudoplatanus</i>)	52.13454 °N -8.628274 °W	M	9 m	200 mm	Fair	N 5 m S 1 m E 3 m W 2 m	18	Tree leans North over pathway, is starting to correct @ 5 m to straighten up, leans North over pathway, is starting to correct @ 5 m to straighten up, healthy tree	No work required	C2	>25

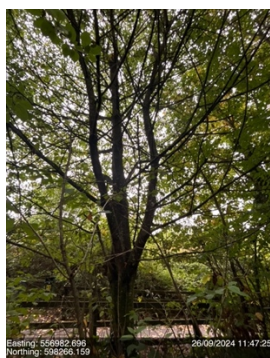
Fig 37: T0188

Tag No.	Species	Coordinates	Age	Height	Diameter	Condition	Crown Spread	RPA (M ²)	Comments	Recommendations	RC	ERC
0188	Bird cherry (<i>Prunus padus</i>)	52.134583 °N -8.62836 °W	M	10 m	400 mm	Good	N 4 m S 4 m E 4 m W 4 m	72	Fine example, straight stem, balanced branch structure, symmetrical form	Deadwood - remove major deadwood	B1	>30

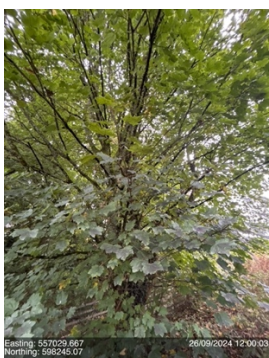
Fig 38: T0189

Tag No.	Species	Coordinates	Age	Height	Diameter	Condition	Crown Spread	RPA (M ²)	Comments	Recommendations	RC	ERC
0189	Sycamore (<i>Acer pseudoplatanus</i>)	52.134397 °N -8.627675 °W	M	13 m	800 mm	Good	N 4 m S 4 m E 4 m W 4 m	290	Lapsed coppice stool, 3 no. Stems from 2 m, evenly spreading crown, healthy tree	No work required	B2	>30

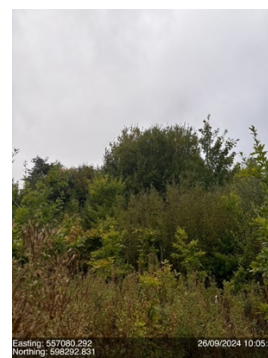
Fig 39: Group 1

Group No.	Species	Coordinates	Age	Height	Diameter	Condition	Crown Spread	RPA (M ²)	Comments	Recommendations	RC	ERC
1	Birch (<i>Betula</i> sp.), Willow (<i>Salix</i> sp.), Sycamore (<i>Acer pseudoplatanus</i>)	52.134721 °N -8.626842 °W	Y	3 - 7m	120 mm	Fair	N 1m S 1 m E 1 m W 1 m	7	Group of young self-seeded pioneering species, these trees have proliferated in this section as water and nutrient run down the hill, these tree species are of low value and typical of what one might see on a derelict site	Fell to ground	C1	>20

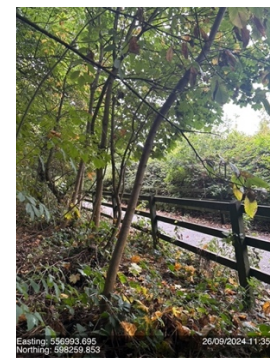
Fig 40: Group 2

Group No.	Species	Coordinates	Age	Height	Diameter	Condition	Crown Spread	RPA (M ²)	Comments	Recommendations	RC	ERC
2	Sycamore (<i>Acer pseudoplatanus</i>)	52.134297 °N -8.627713 °W	Y	3 m	70 mm	Fair	N 2 m S 1 m E 1 m W 1 m	3	Group of self-seeded sycamores that grow on the edge of the pathway, these will need to be thinned out in the medium term future	No work required	C2	>30

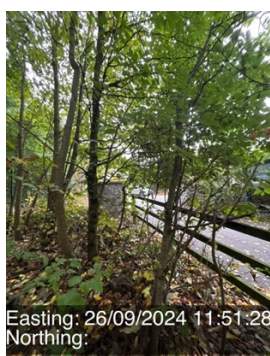
Fig 41: Group 3

Group No.	Species	Coordinates	Age	Height	Diameter	Condition	Crown Spread	RPA (M ²)	Comments	Recommendations	RC	ERC
3	Beech (<i>Fagus sylvatica</i>), Sycamore (<i>Acer pseudoplatanus</i>)	52.134561 °N -8.628366 °W	SM	4- 6m	170 mm	Fair	N 2m S 1 m E 1 m W 1 m	13	Group of self-seeded trees that grow on the edge of the woodland	No work required	C1	>20
