# DMURS Quality Audit

Proposed Large Residential  
Development at Castlelands,  
Mallow, Co. Cork

Reside (Castlepark) Ltd

October 2024

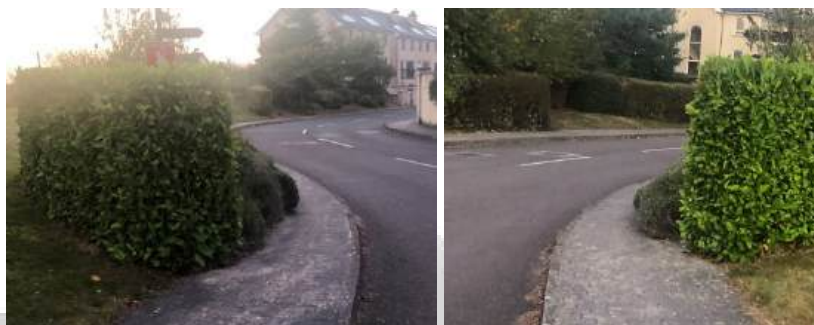
The clear width of the Kingsfort Avenue north east side footway, located opposite Bower Walk, is restricted by vegetation growth, as shown in the hereunder photographs. The visibility of the warning sign (Caution Children At Play) for inbound drivers is also restricted by the vegetation.

**Photographs 3-4 : Kingsfort Avenue Footway & Sign Restricted by Vegetation**

**Suggestion:** It is recommended that the vegetation should be cut back and maintained to provide a clear footway width and signage visibility.

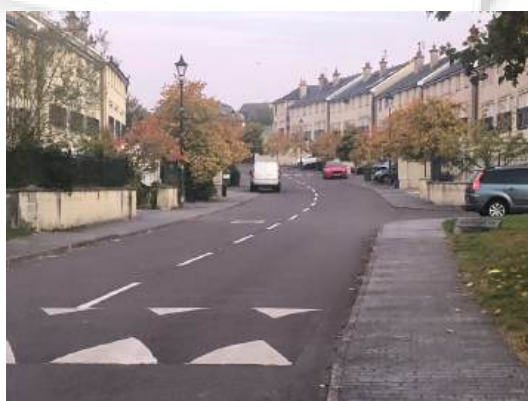
There is no Slow Zone/Homezone speed limit signage provided on the Kingsfort Avenue and Castlepark Avenue access streets to the existing Castlepark/Castlelands residential estate, with reference to DMURS and the DoT Traffic Signs Manual. A reduced speed limit of 30 km/hour is standard in urban residential estates.

**Photograph 5: Kingsfort Avenue Streetscape**

**Suggestion:** It is recommended that standard 30 km/hour Slow Zone speed limit signage should be provided on the Kingsfort Avenue and Castlepark Avenue access streets to the existing Castlepark/Castlelands residential estate, with reference to DMURS and the DoT Traffic Signs Manual.

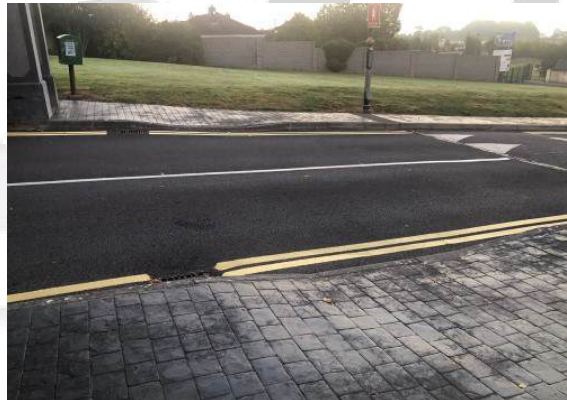
Pedestrian users of the St. Joseph's Road footway don't have priority at the junction and no defined dished crossing location is provided along the pedestrian desire line. Kingsfort Avenue has a dished internal crossing location adjacent to the St. Joseph's Road junction, with an adjacent traffic calming ramp. A raised table Stripe marking pedestrian crossing is located on Kingsfort Avenue prior to (west of) the first internal junction.

**Photograph 6: Kingsfort Avenue Adjacent to St. Joseph's Road Junction**

**Suggestion:** It is recommended that enhanced junction layouts and facilities for pedestrians should be provided at the existing access junctions on St. Joseph's Road, in consultation with Cork County Council.

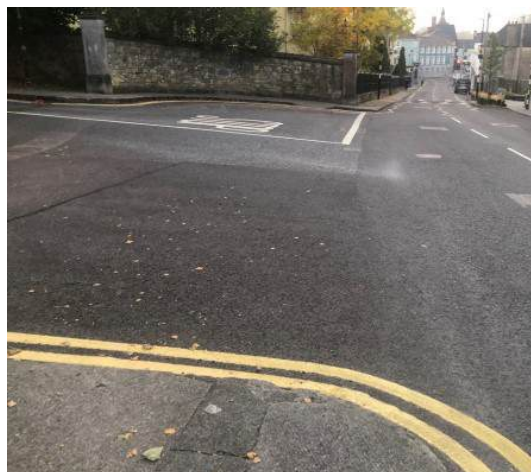
The Castlepark Avenue junction has a relatively long crossing distance, without priority, for pedestrian users of the St. Joseph's Road footway, with non-aligned existing footway dishing; and no defined internal crossing location on the adjacent Castlepark Avenue.

**Photograph 7: Castlepark Avenue at its St. Joseph's Road Junction**

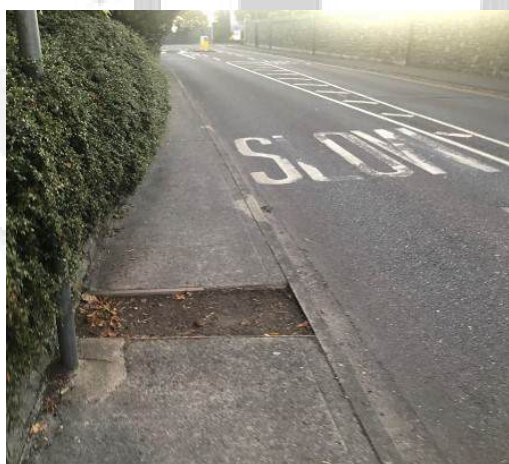
The footway on the north west side of St. Joseph's Road, located immediately south west of the Kingsfort Avenue access junction, is uneven locally, as shown in the hereunder photograph, resulting in a potential trip hazard.

**Photograph 8: View North East of St. Joseph's Road North West Side Footway**

**Suggestion:** It is recommended that the St. Joseph's Road footway should be reinstated, locally, in consultation with Cork County Council.

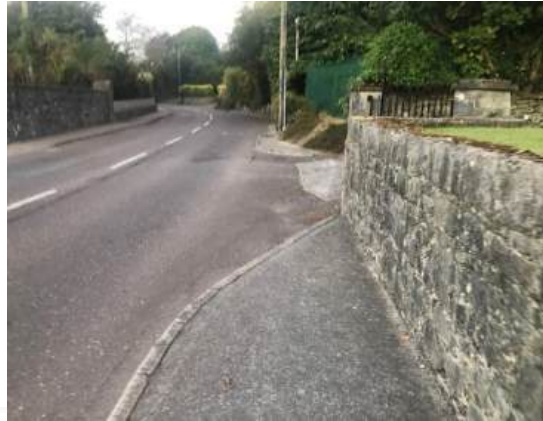
The footway on the north west side of St. Joseph’s Road, located immediately south west of the Kingsfort Avenue access junction, is discounted, as shown in the hereunder photograph, resulting in a potential hazard for users.

***Photograph 9: View North East of St. Joseph’s Road North West Side Discounted Footway***

**Suggestion:** It is recommended that the provision of an uncontrolled pedestrian crossing is investigated at this location on the St. Joseph’s Road to locally connect the footways on either side of the road, in consultation with Cork County Council.

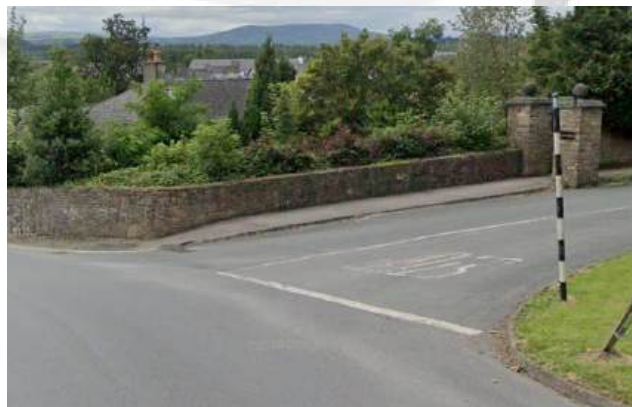
The footway on the north west side of St. Joseph’s Road, located immediately south of the Castle Grove access junction, is discounted, as shown in the hereunder photograph, resulting in a potential hazard for users.

***Photograph 10: View of Discounted Footway on St. Joseph’s Road close to Castle Grove***

**Suggestion:** It is recommended that the provision of an uncontrolled pedestrian crossing is investigated at this location on the St. Joseph’s Road to locally connect the footways on either side of the road, in consultation with Cork County Council.

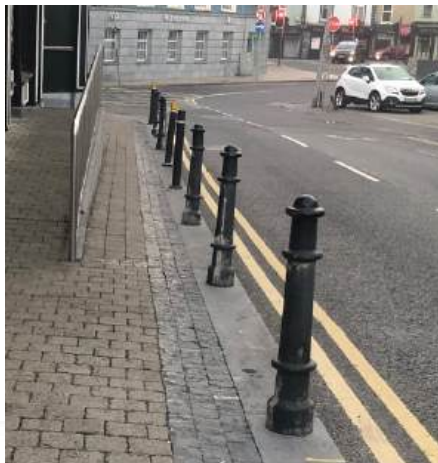
The St. Joseph's Road south east side footway is restricted at its town centre end by bollards, locally, as shown in the hereunder photograph.

**Photograph 11: View South West of St. Joseph's Road North West Side Footway**

**Suggestion:** It is recommended that an appropriate clear width footway should be provided, with reference to DMURS, in consultation with Cork County Council.

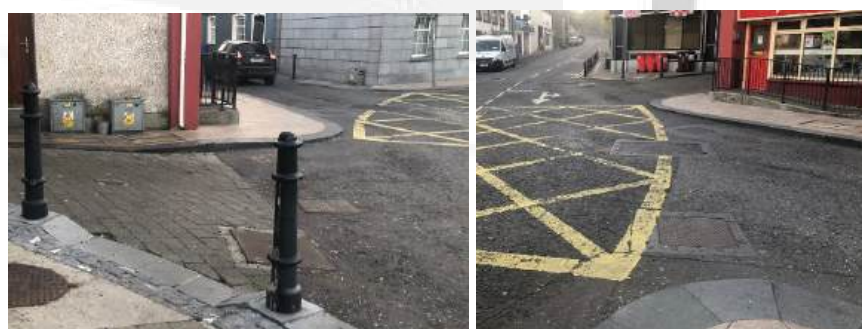
The footways and crossing locations at the town centre tie-ins are incomplete/restricted at the St. Joseph's Road/Infirmary Lane/Bridewell Lane intersection, as shown in the hereunder photographs.

**Photographs 12-13: Views of St. Joseph's Road North West Side Footway End Tie-Ins**

**Suggestion:** It is recommended that appropriate footway widths and crossing facilities should be provided, with reference to DMURS, in consultation with Cork County Council.

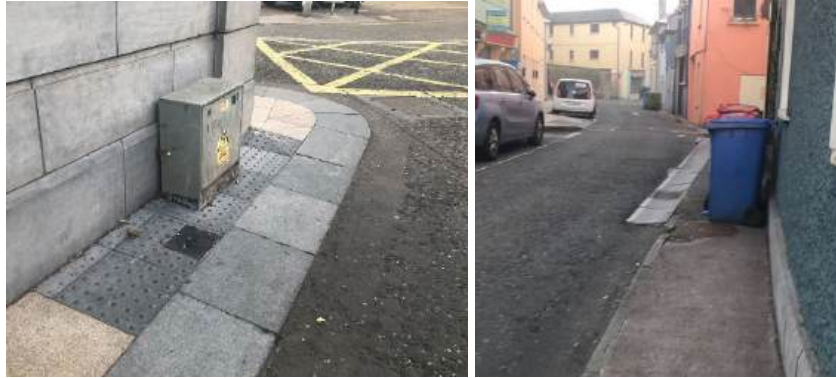
**Photographs 14-15: Views of Bridewell Lane West Side Footway**

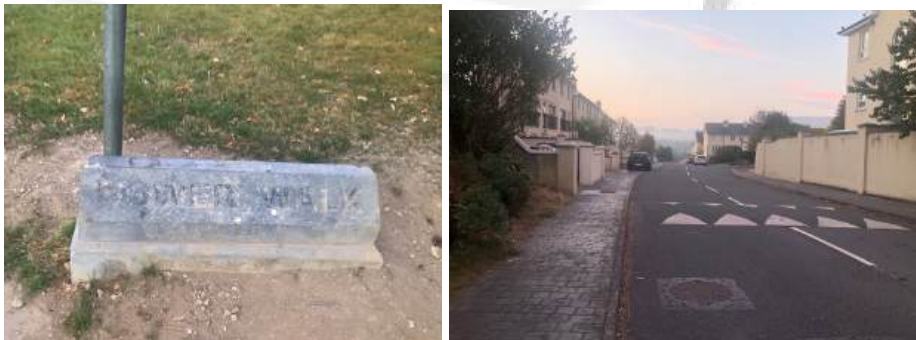
There is limited and unclear directional signage and road naming throughout the existing estate, in particular along Kingsfort Avenue and Castle Park Avenue, as shown in the hereunder photographs.

**Photographs 14-15: Unclear and Lack of Directional Signage within the Existing Residential Estate**

**Suggestion:** It is recommended that directional signage and road naming should be upgraded through the estate from the 2 No public road entrances on St Joseph’s Road along Kingsfort Avenue and Castle Park Avenue to aid traffic through the site and to minimize potential disturbance of existing residential areas with through traffic.

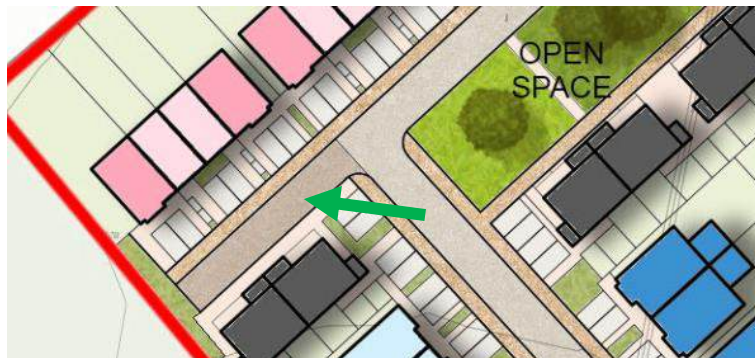
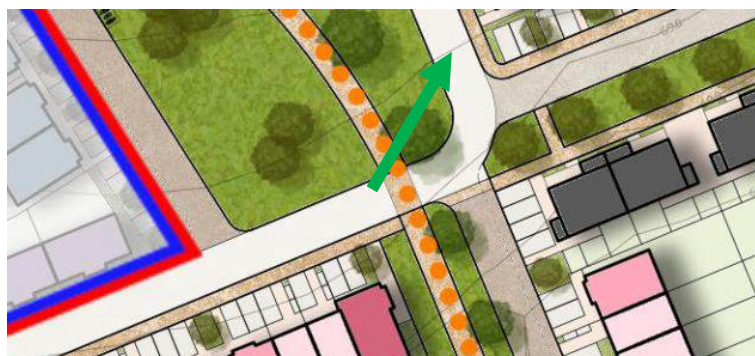
**Problem:** The design incorporates a number of sharp bends and tight junctions. Some of these bends and/or junctions have development plots, landscaping or car parking bays located to the inside of the bend. Buildings, high landscaping or high sided vehicles parked in the bays may restrict forward visibility for motorists.

**Hazard:** Motorists may impact with unseen road users, crossing pedestrians or detritus in the carriageway.

**Recommendation:** The design team should ensure suitable forward visibility is provided throughout the scheme.

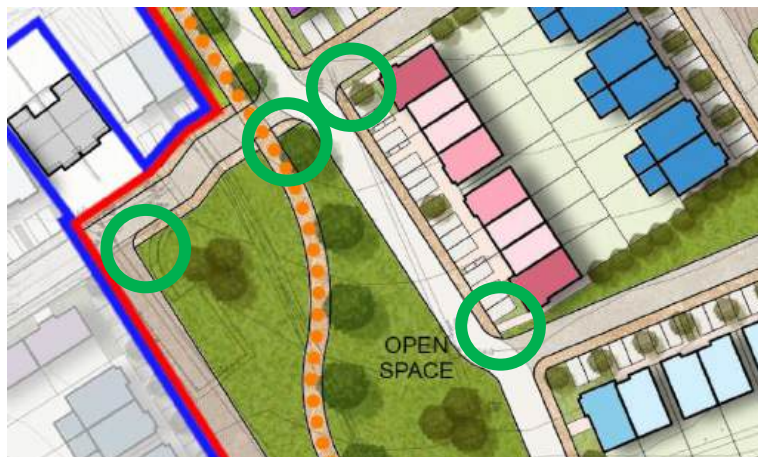
**Problem:** The proposed development indicates footpaths terminating at the junction radii. It is not clear how these footpaths will incorporate dropped kerbs or tactile paving. In some cases, the footpath does not align with the continuation on the opposite side of the road.

**Hazard:** Sight or mobility impaired pedestrians may errantly enter the carriageway into the path of oncoming traffic. Wheelchair and mobility scooter users may be at risk of overturning when negotiating full height kerbs and may be impeded when crossing the carriageway.

**Recommendation:** Suitable dropped kerbs and tactile paving should be provided on all anticipated pedestrian desire lines. The footpath alignment should provide clear continuity to safely connect to the footpath opposite, or lead pedestrians into a clearly defined “shared space”.

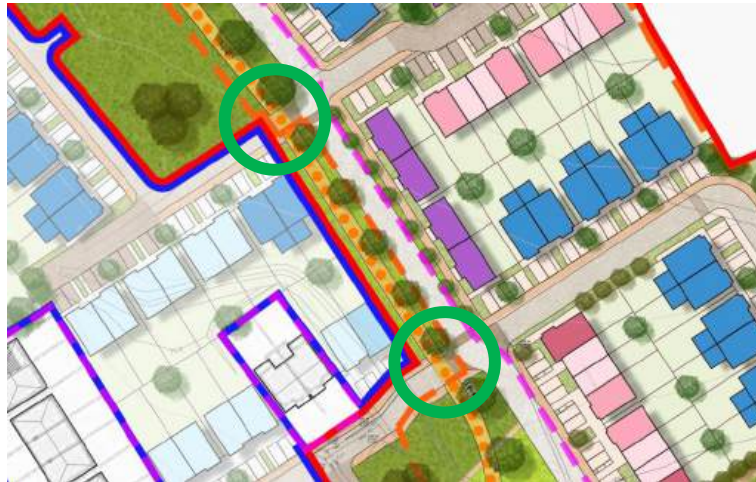
**Problem:** There are a number of locations where the proposed cycle path crosses carriageways and/or footpaths. There is no priority, intervisibility or details shown at these crossing points.

**Hazard:** Cyclists may impact with vehicles or pedestrians.

**Recommendation:** The design team should undertake detailed designs at all intersections and ensure suitable crossing facilities are provided with suitable intervisibility and signage where all users understand the priority.

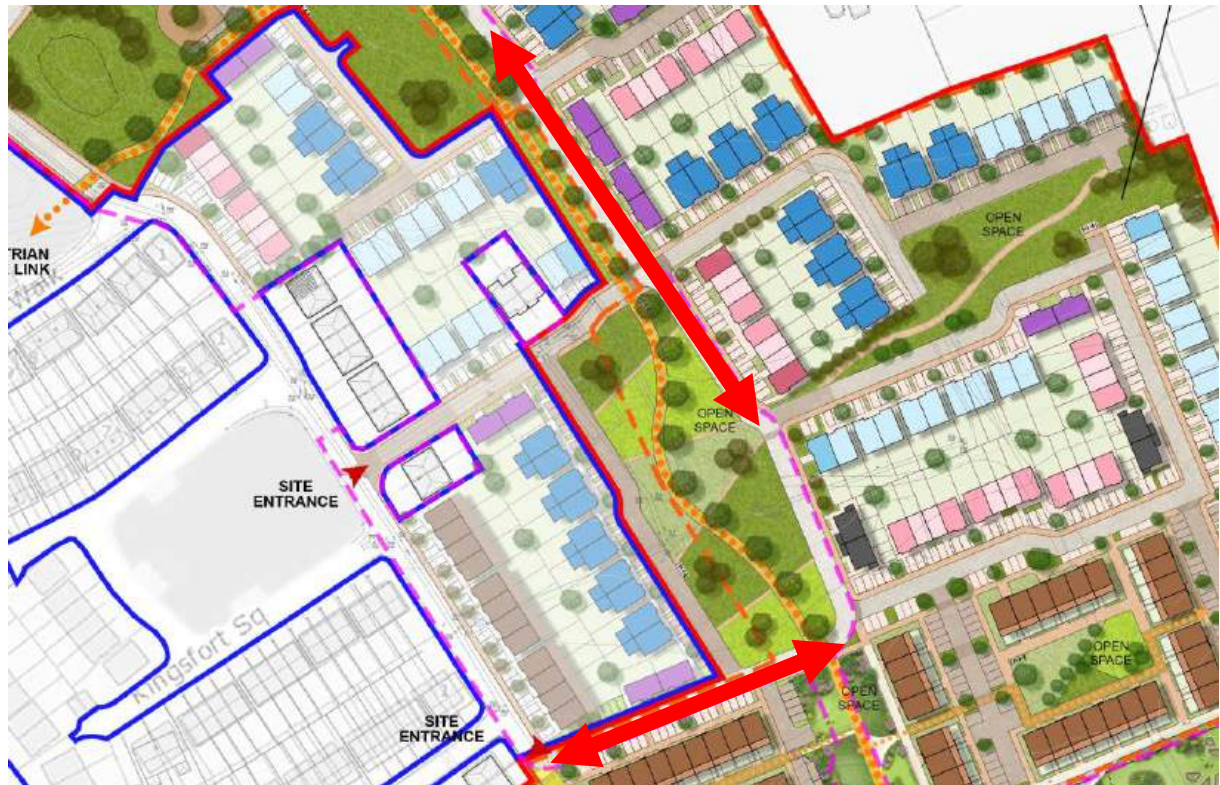
**Problem:** Some of the roads within the development are long and straight. Long and straight roads have a poor history of undesirably high vehicle speeds. Certain roads in this phase incorporate a slight shift in alignment, but this is insufficient to require vehicles to slow if there are no opposing vehicles.

**Hazard:** Vehicle loss of control or high-speed impact with crossing pedestrians may result.

**Recommendation:** The design team should ensure vehicle speeds are controlled to acceptable levels by physical means.

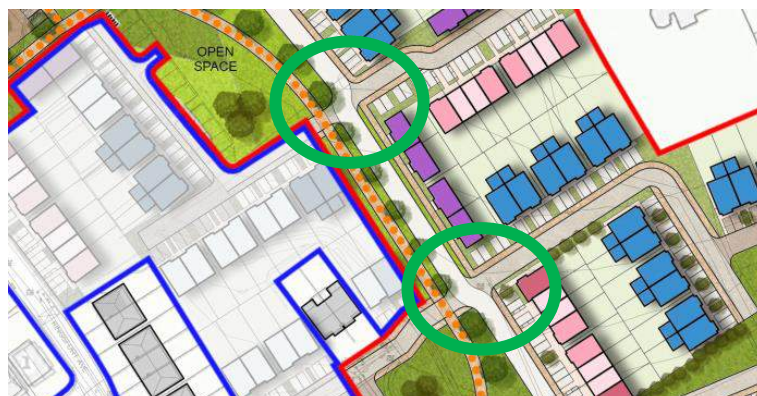
**Problem:** There are crossroads junctions proposed within the LRD development.

**Hazard:** Crossroads junctions have a poor collision history of overshoot type collision.

**Recommendation:** The design team should omit the crossroad junction.

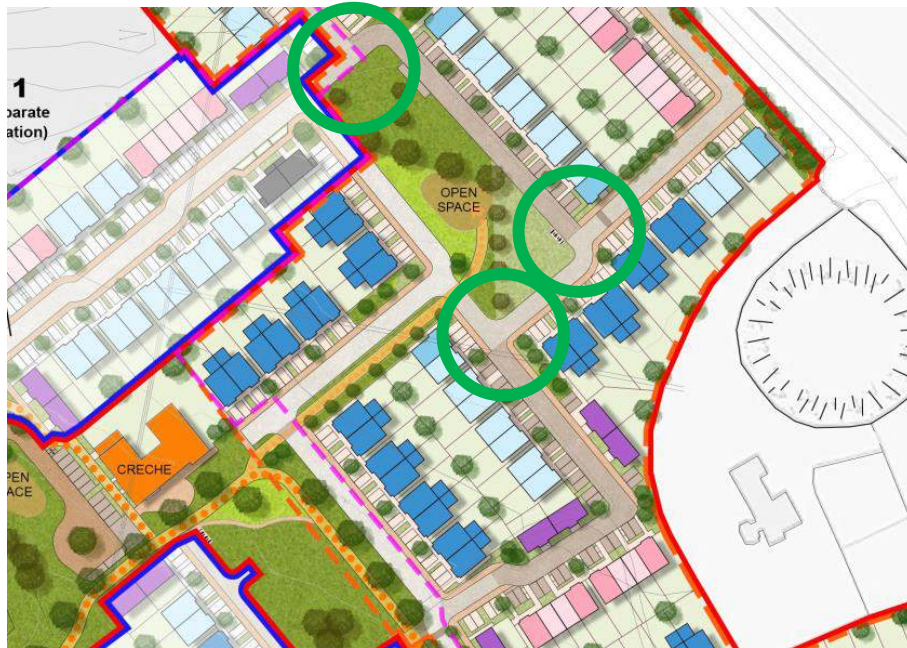
**Problem:** Some of the streets appear to be designated as “shared use” where pedestrians, cyclists and motorists all use the same space. It is not clear how sight impaired pedestrians are meant to transfer from the shared space to the segregated footpath at the carriageway junction. There is concern the sight impaired user may errantly continue to walk out into the carriageway.

**Hazard:** Impact from vehicles may result.

**Recommendation:** The design team should ensure suitable route guidance is incorporated to guide the pedestrian to the segregated footpath.

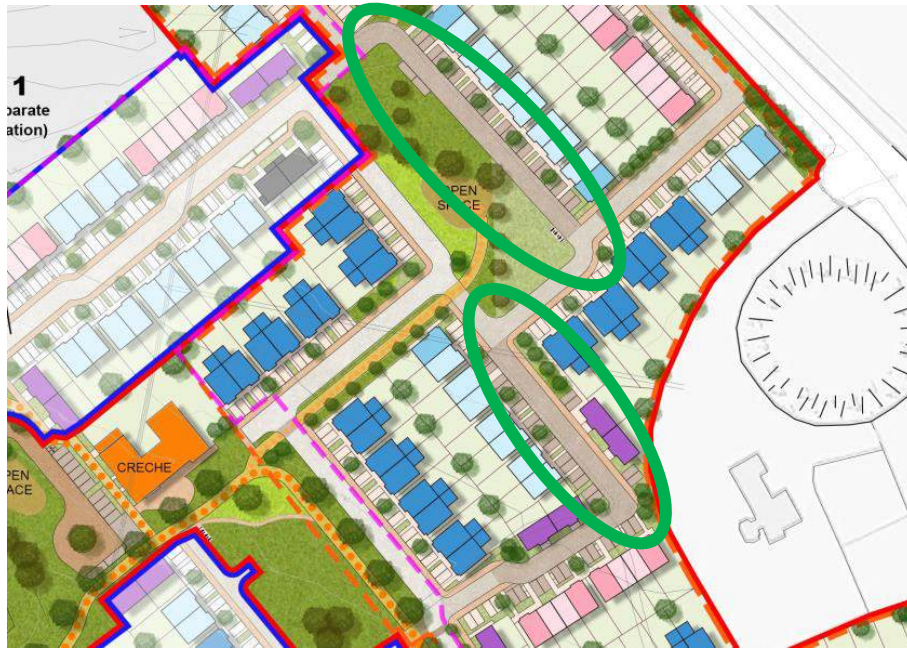
**Problem:** Some of the streets appear to be designated as “shared use” where pedestrians, cyclists and motorists all use the same space, however the design of these spaces appear to be very similar to standard streets elsewhere in the development, including in some areas segregated footpaths.

**Hazard:** Motorists may not comprehend the nature of the space and drive without sufficient care. Impact with pedestrians who are in the process of entering the space may result.

**Recommendation:** The design team should ensure there are sufficient physical features provided within the space (bends, tree planting, street furniture, etc.) to ensure the motorist understands the shared use intent and that they are invited into a pedestrianised space.

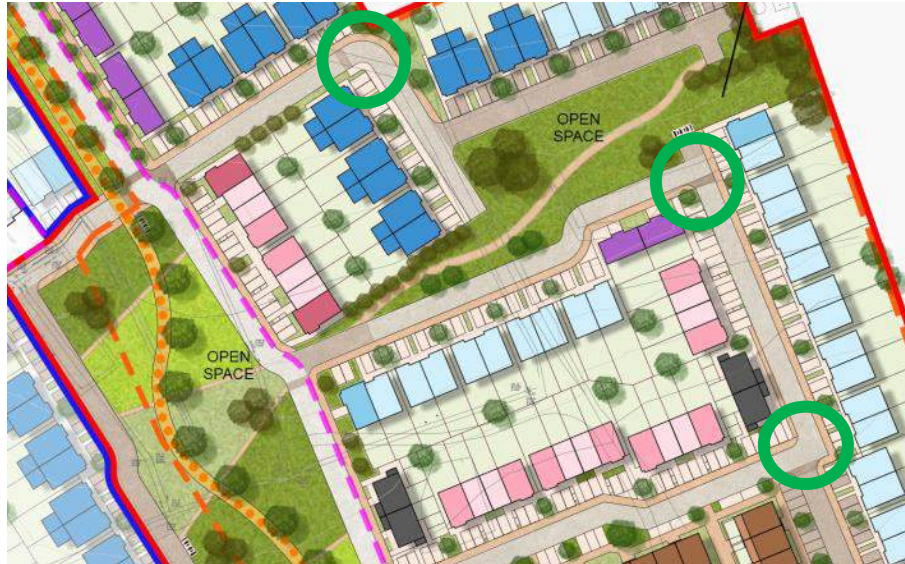
**Problem:** The carriageway contains very tight bends where large service vehicles are expected to navigate.

**Hazard:** Long vehicles may over-run the inside of the bend. Pedestrians may be struck by a vehicle if it overruns the footpath. Where there is no footpath, detritus may be dragged into the carriageway. Following vehicles, possibly two-wheeled vehicles, may lose control on the detritus.

**Recommendation:** The design team should undertake vehicle swept path analysis and redesign the carriageways alignment to accommodate large service vehicles.

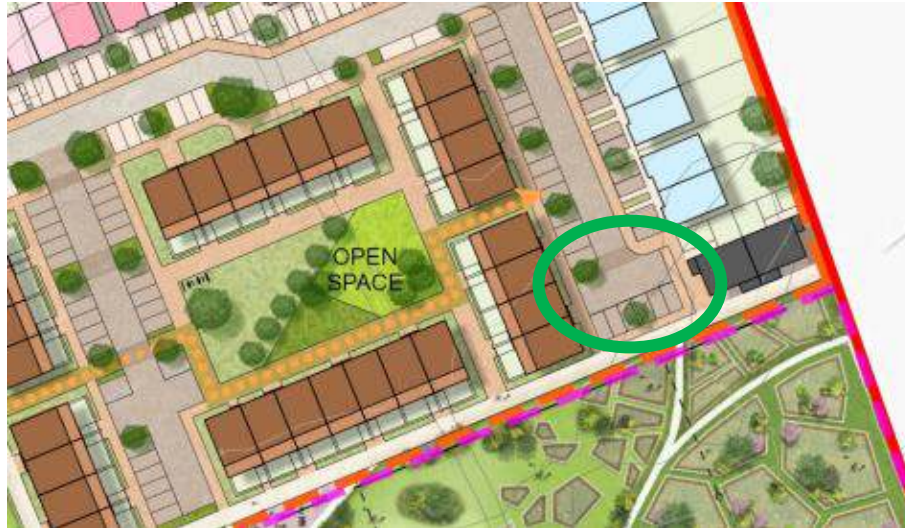
**Problem:** The turning heads appear small. It is not clear if this turning head can accommodate turning of service vehicles.

**Hazard:** Service vehicles may be required to reverse over long distances. Impact with other vehicles or crossing pedestrians may result.

**Recommendation:** The design team should undertake swept path analysis for the service vehicle sizes used by the operators in this area and redesign the turning heads to suit.

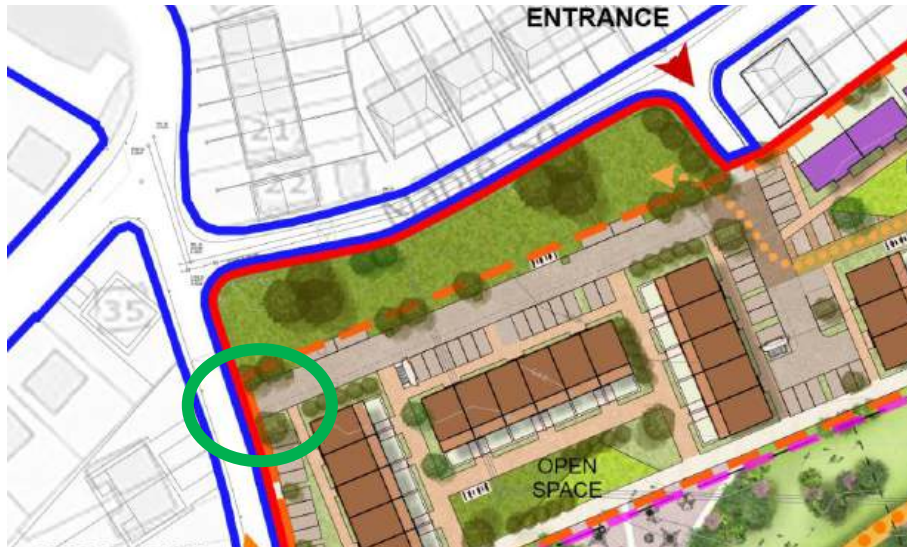
**Problem:** The proposals include for an access road parallel with Maple Square without any vehicle turning facility. There does not appear to be a vehicle link through to Maple Wood. Service vehicles who enter this road may be required to reverse over a long distance.

**Hazard:** Impact with other road users may result.

**Recommendation:** Provide a suitable turning head.
