County Tree Care Ltd

Tree Survey and Arboricultural Assessment at Mallow , Co. Cork

Date : 03/10/24

McCutcheon Halley,
Joyce House,
6 Barrack Square,
Ballincollig,
Co. Cork

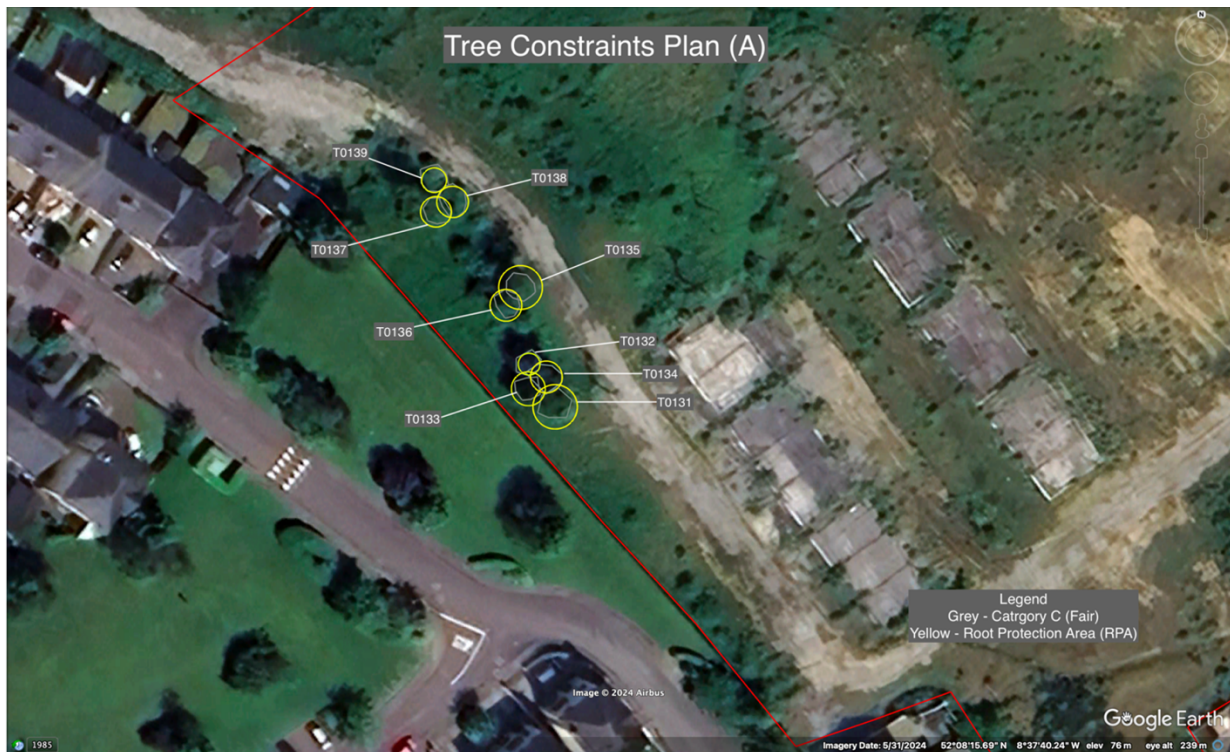
Fig 44: Tree Constraints (A)

The trees Northern section of the site were planted for amenity reasons as part of a landscape plan originally. All of these specimens are of fair quality and are placed in category C (grey). They have not been maintained and heavy grass grows around the base which would take valuable nutrient and water from the roots. They are still alive and reasonably healthy. Of these trees there are 5 no. silver birch (*Betula pendula*). This species is a good choice in developed areas due to the fact that they don't get too large and do not have a dense crown. The small leaves and light branches offer dappled shade and they don't block out the sun to a large degree. There are 3 no. ornamental plum (*Prunus cerasifera*). These are small trees and were recommended to be retained due to the purple leaf colour and contrast in growing habit to the birch, as was the intention with the original design. There is one sycamore (*Acer pseudoplatanus*) that has possibly self-seeded and is at odds with the other species choice. It is healthy, has a straight stem and is fairly symmetrical in form. These trees are all of fair quality and could offer something to the site in relation to softening the background of the already developed housing to the South. The root protection area (RPA) of these trees have been outlined in yellow in Fig 44, Fig 45 and Fig 46 and in magenta outline in the Tree Constraints Plan in the AutoCAD drawing file.
