# DMURS Quality Audit

Proposed Large Residential  
Development at Castlelands,  
Mallow, Co. Cork

Reside (Castlepark) Ltd

October 2024

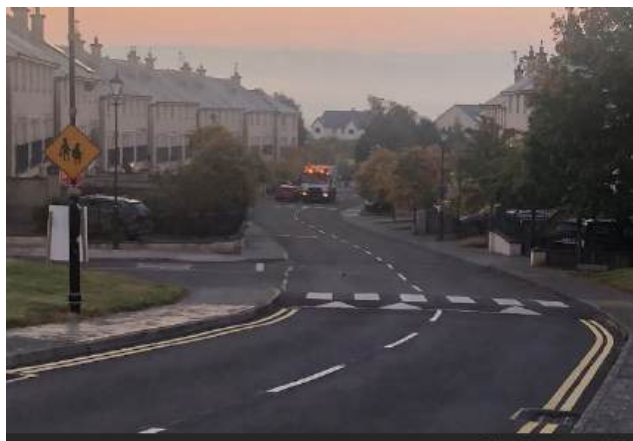
Footways are provided along both sides of Kingsfort Avenue. A vertical traffic calming ramp is provided on Kingsfort Avenue adjacent to its St. Joseph's Road junction. A raised table Stripe marking pedestrian crossing facility is provided on Kingsfort Avenue, immediately west of its Scoil Aonghusa Community National School access junction, as shown in the hereunder photograph. A series of vertical traffic calming ramps are provided along Kingsfort Avenue east of the raised pedestrian crossing facility.

**Photograph 1: View East of Kingsfort Avenue Raised Crossing**

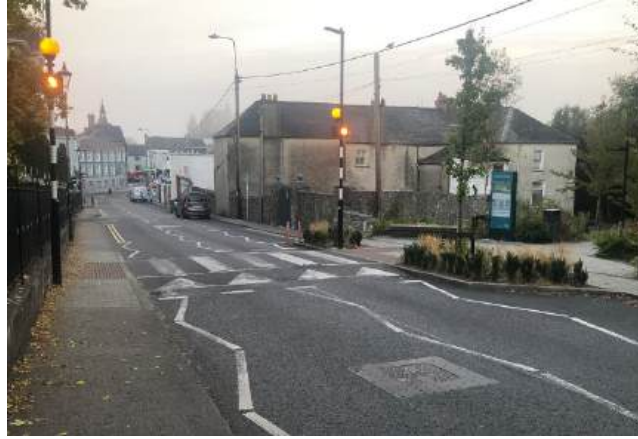
A Zebra pedestrian crossing is provided on St. Joseph's Road, south of its Castlepark Avenue junction, as shown in the hereunder photograph.

***Photograph 2: View South West of St. Joseph's Road Zebra Crossing***

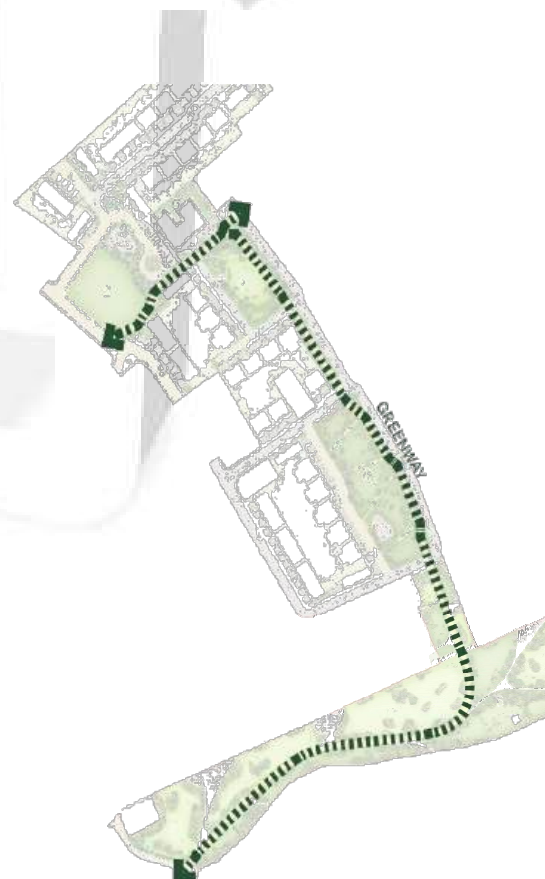
With the proposal to connect to and utilise the existing Riverside Amenity Walk as a thoroughfare for cycle traffic a potential constraint beyond the site could be seen as the 1.5m wide trussed bridge spanning a minor tributary to the Blackwater – by way of a financial contribution the developer would be amenable to upgrade this bridge to a concrete bridge that matches the 3.3m wide concrete path adjacent.
